**VEHICLE AND SURVIVAL FACTORS ATTACHMENT 5 – MOUNTAIN VIEW FD
SAFETY ALERT**

HWY18FH011

MEMORANDUM#43-18

SUBJECT: Safety Alert – Electric Vehicles High-Voltage Battery Fire

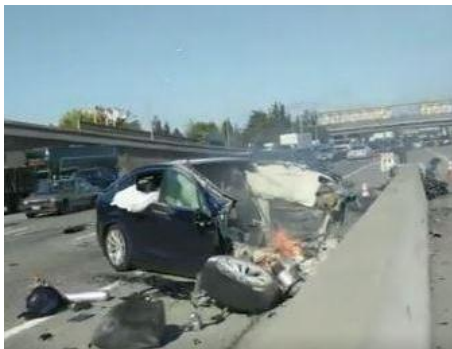
On March 23, 2018, the Mountain View Fire Department responded to a MVA SB101 at Highway 85 involving three vehicles. One of the vehicles involved was an electric vehicle (EV), a Tesla Model X. On the arrival of E55, the electric vehicle's 400-volt battery pack had significant intrusion due to the collision, it was clearly damaged, and it was also on fire. The driver, the single occupant of the Model X, had been extricated by other motorists and was unconscious. There were no other victims. E53 and E55 personnel rendered care and extinguished the vehicle and battery fire with approximately 200 gallons of water. It was noted that full extinguishment of the EV occurred within two minutes. Water application to the exposed battery pack was stopped after approximately 10 minutes of being on scene due to no obvious signs of fire in the battery. The critically injured driver was transported to Stanford Hospital Trauma Center in the care of two MVFD Firefighter Paramedics. The patient, despite efforts, later succumbed to his injuries in the ER.

Picture prior to FD arrival

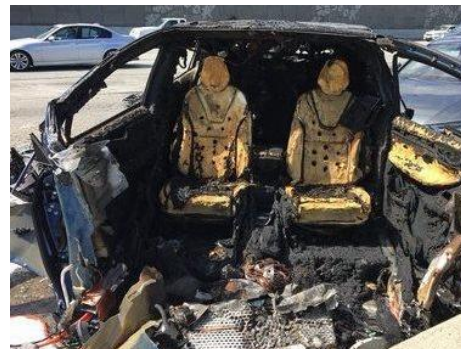
1. While the actual flames emanating from the battery were extinguished, there was no practical means to deenergize the damaged Lithium-ion battery cells as there was no access to all of the battery. In addition, first responders are not qualified for such deenergizing process. Deenergizing may be accomplished by disassembly of the battery cells one by one or by connecting to the battery to an electrical appliance and performing a battery draw down. Both of these procedures are not within the scope of MVFD personnel.
2. The damaged battery presented a concern of electric shock as many of the cells and high voltage wires were exposed.
3. Due to the short-circuit event that had occurred when the battery's interior was breached in the collision, the battery cells continued to generate heat in a known deenergizing process called "thermal runaway."

Faced with this dilemma, the IC opted to have the vehicle's manufacturer respond to the scene to provide their expertise in eliminating the thermal runaway and electrical hazards. After approximately two hours into the event, Tesla engineers arrived and attempted to dismantle as much of the damaged battery cells/modules as they could. They meticulously removed each cell, one by one. Approximately 25 percent of the battery was removed and several of its high-voltage wires had been isolated. However, the rest of the battery's cells were not accessible without removal of the main battery from the vehicle and the determination was made that the vehicle was safe enough to be towed. At approximately 5-1/2 hours into the event, the vehicle was safely towed to the CHP impound yard with an escort from MVFD E55. The escort was necessary due to the potential for reignition as not all of the battery cells had been removed. During transport, the battery continued to exhibit signs of deenergizing, but no reignition occurred during transport. However, the battery reignited (twice) in the storage yard during its first 24 hours and reignited again six days later on Thursday, March 29, 2018.

Damaged battery front bottom

2. **Cooling Process:** Cooling of the battery's modules and cells is an effective manner in preventing reignition. During NFPA testing, it was determined that it could take 2,600 and up to 3,000 gallons to effectively cool down the battery. However, this cooling can only take place as long as the water is introduced inside the battery. Use of the thermal imager camera can facilitate the status of the internal thermal runaway and determine if temperatures are going up or down.

- a. If a battery is mostly still intact, as was the case in our EV fire, it will be nearly impossible to penetrate all of the modules and cells. Thus, expect reignition

of the battery to occur for days. One option to ensure penetration into the battery is to completely submerge the battery in water. This can be accomplished by creating a dam around the vehicle and filling the dam with water, ensuring the battery is fully submerged.

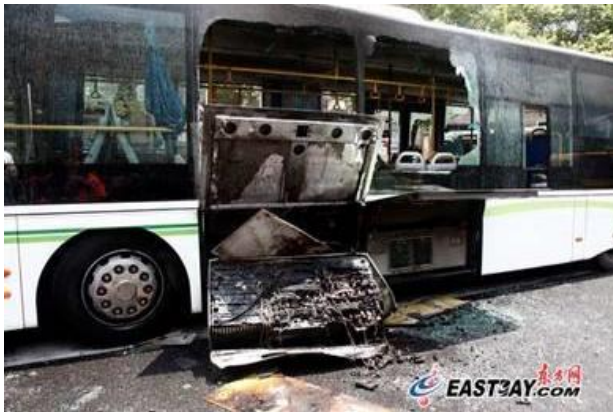
EV bus in China

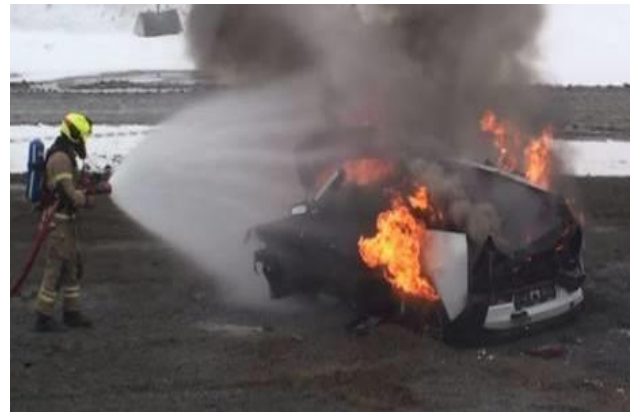
BMW i3 in a Norwegian test

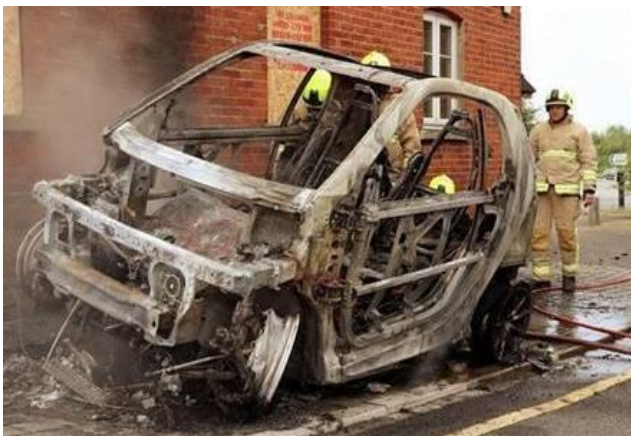
E Smart car on a charger in the UK

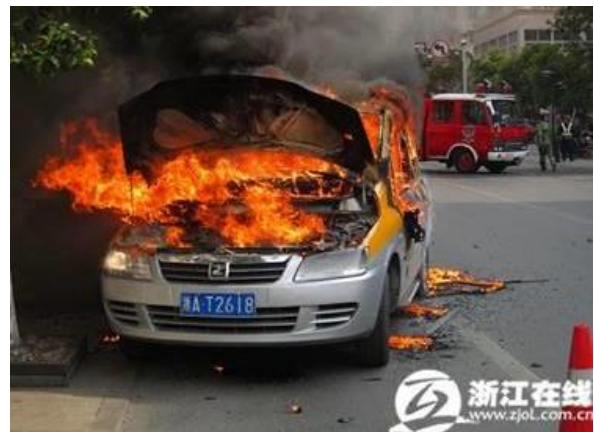
Zotye taxi in China

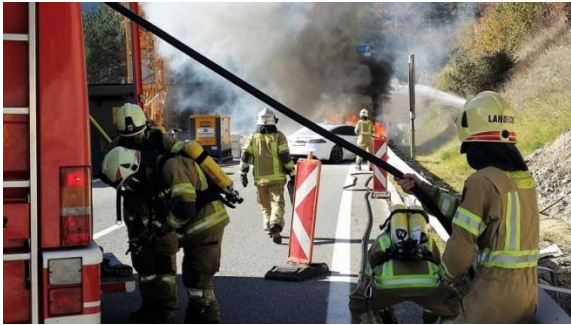
Tunnel entrance in Austria with a Tesla on fire

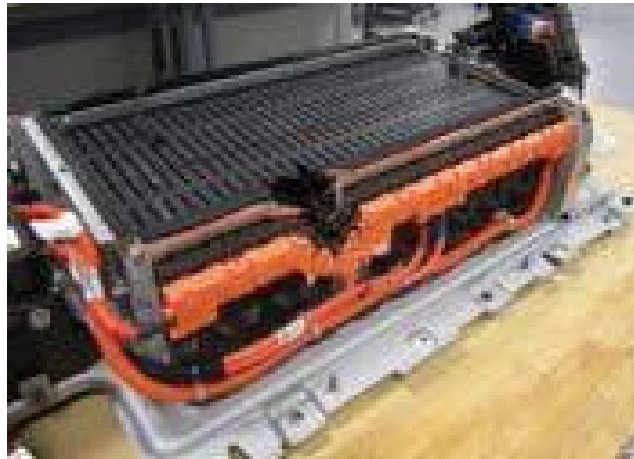
Remember to always avoid contact with a damaged high-voltage (HV) battery as a significant shock hazard may exist. An HV battery should always be considered to contain a charge and should never be touched or pried open.

Damaged EV Battery – Source: NFPA
